## Home Inspection Report

PROPERTY INSPECTED:  
**26 Heale Avenue**  
Toronto, ON M1N 3X7

Date of Inspection: 11/19/2024

Inspection No. 141465-1167

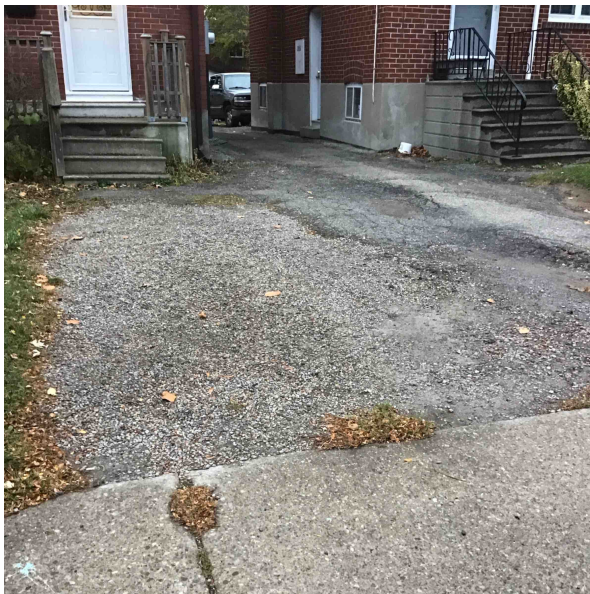
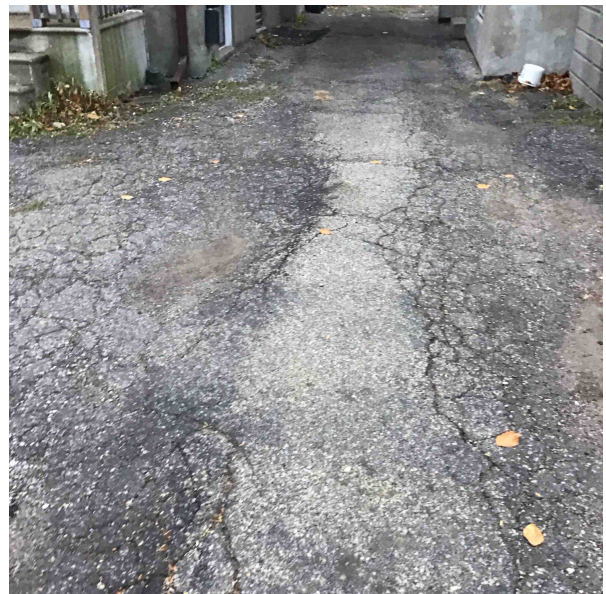
2.3.2 The driveway is worn / uneven / rutted. This surface is near the end of its service life. Consider resurfacing / replacing. **(Exterior - Right)**

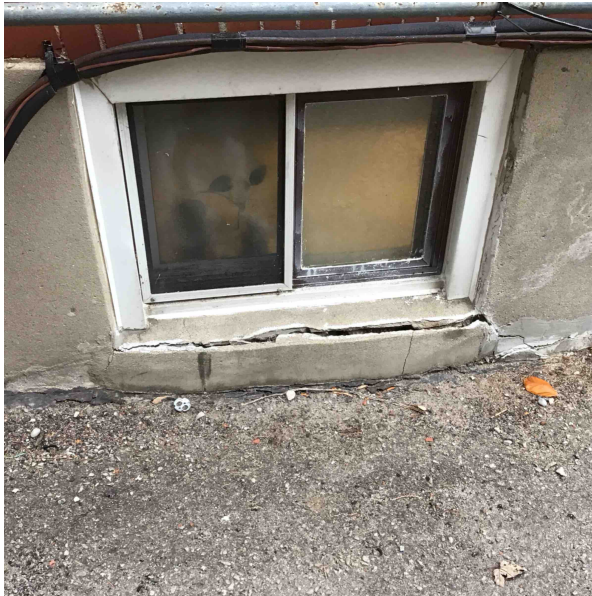
3.2.2 Foundation surface is damaged in areas and should be repaired to shed water from the foundation.

**(Exterior - Right)**

3.2.1 Attention is required to repair the foundation

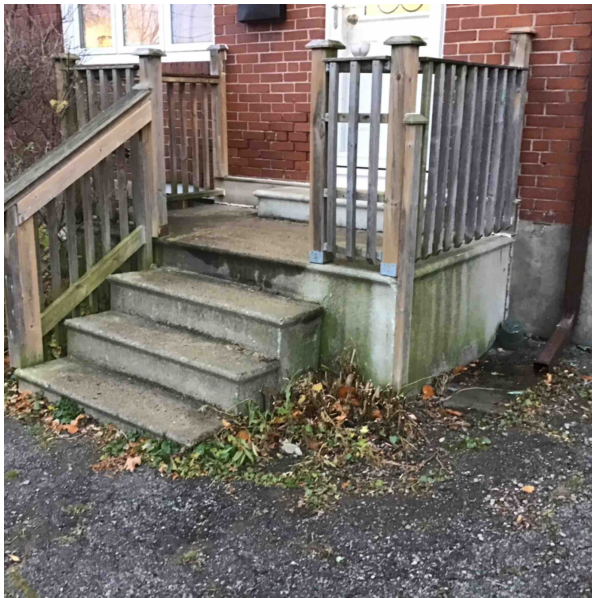
3.8.2 The porch is missing guard/handrails. Install where required to prevent injury and improve safety. **(Front Porch)**

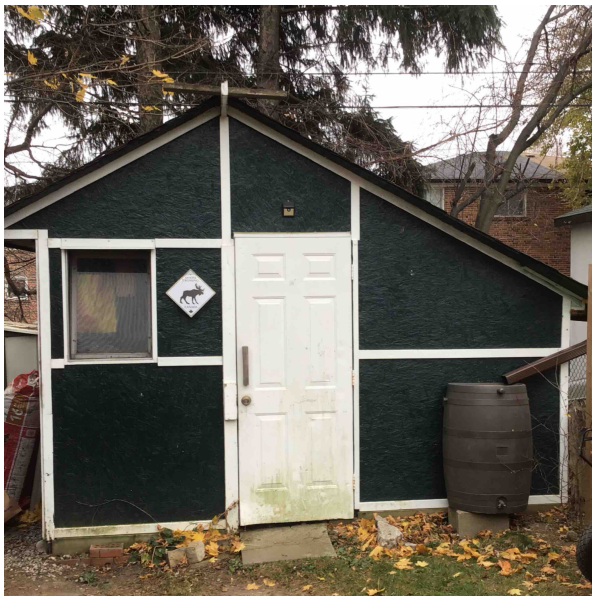
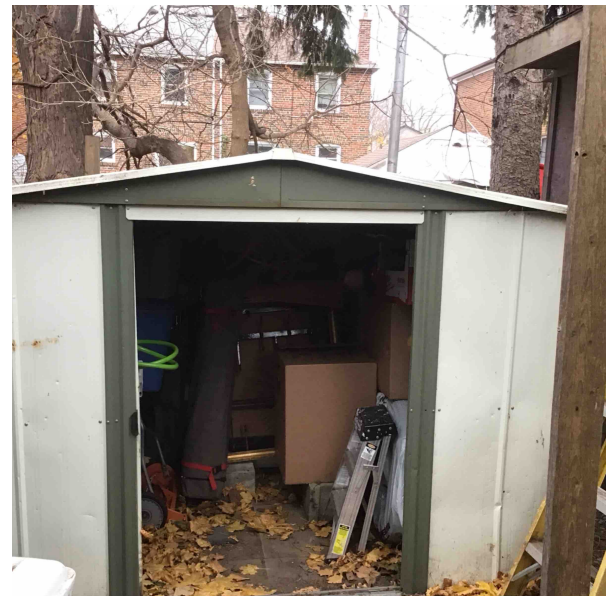
3.10.2 The exterior storage cladding / walls are worn. Repair or replace as needed to restore structural integrity.

The roof system is in the middle of there lifespan. **(Shed)**

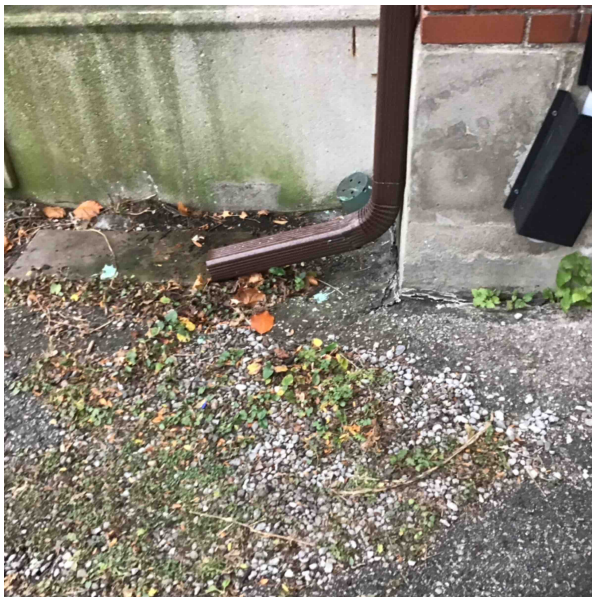
4.6.1 Downspouts discharge near base of foundation

4.6.2 The downspouts are not extended. Extend downspouts to limit water entry into the basement (**Exterior - Front**)

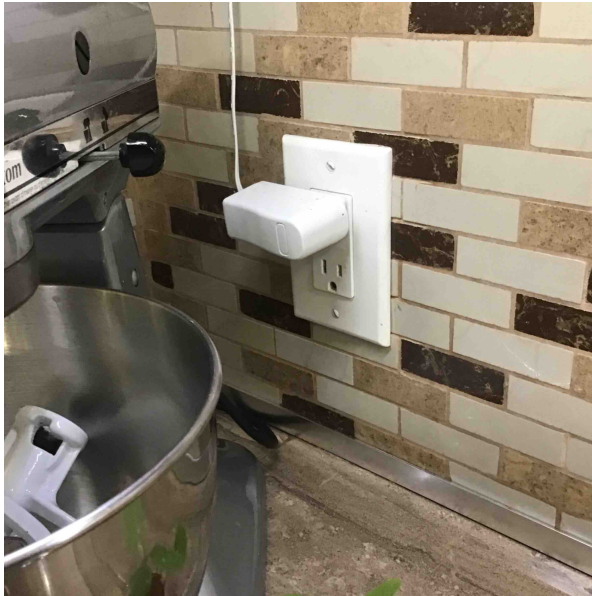
7.13.2 The GFCI(s) are missing. A qualified electrician should further assess and correct as required for electrical safety. **(Kitchen)**

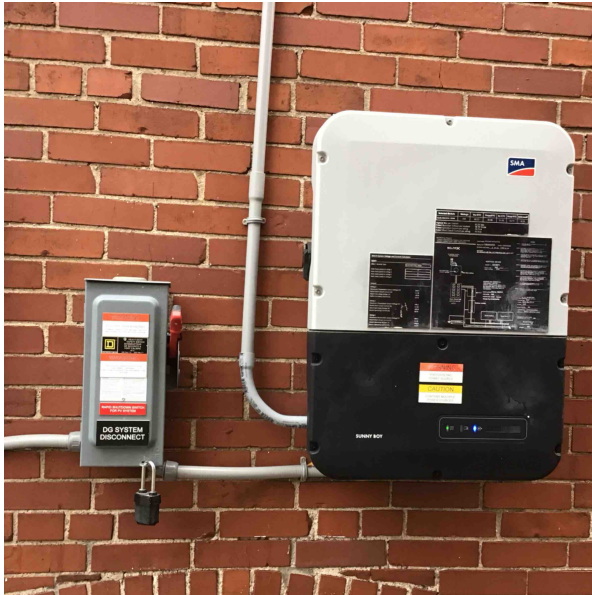
7.17.1 The dwelling is outfitted with solar collectors that supports the dwellings electrical usage.

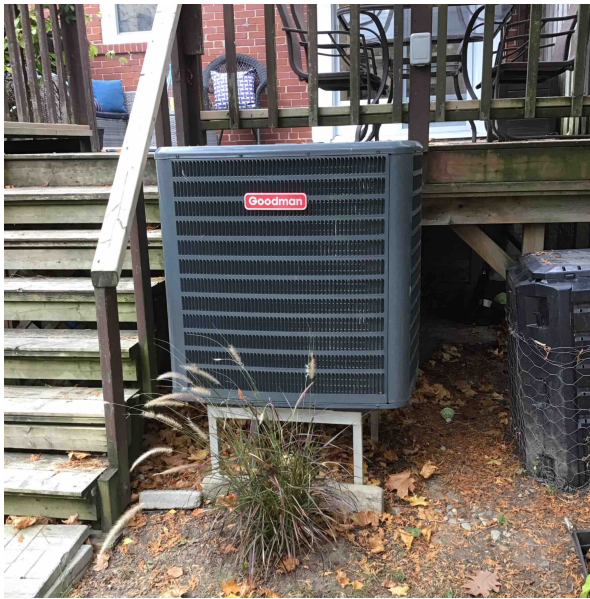
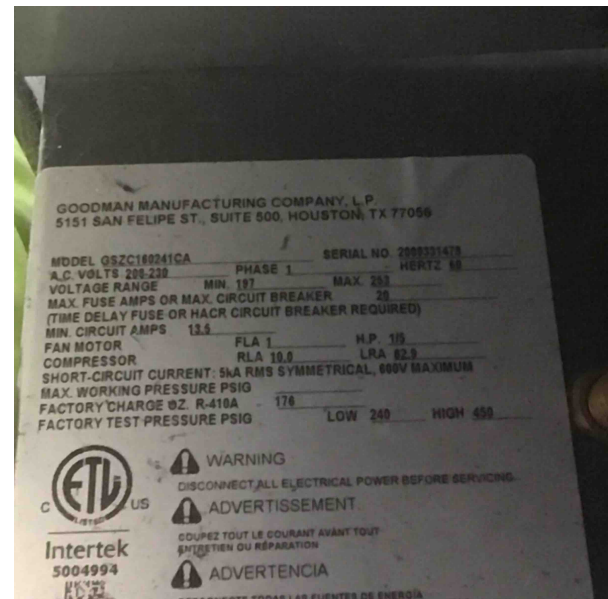
8.6.2 The dwelling has a newer Goodman heat pump system. **(Exterior - Rear)**

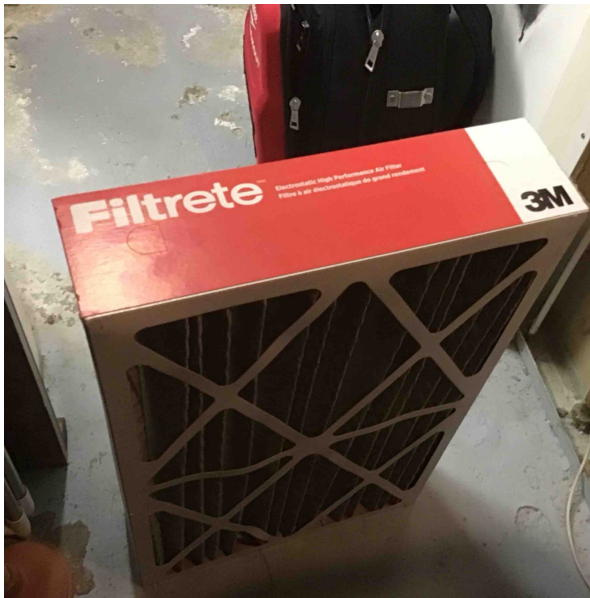
8.11.4 We would suggest that the furnace filter be changed or cleaned upon occupancy and quarterly inspections be performed. Dirty filters affect HVAC lifespan. **(Mechanical Room / Utility Room)**

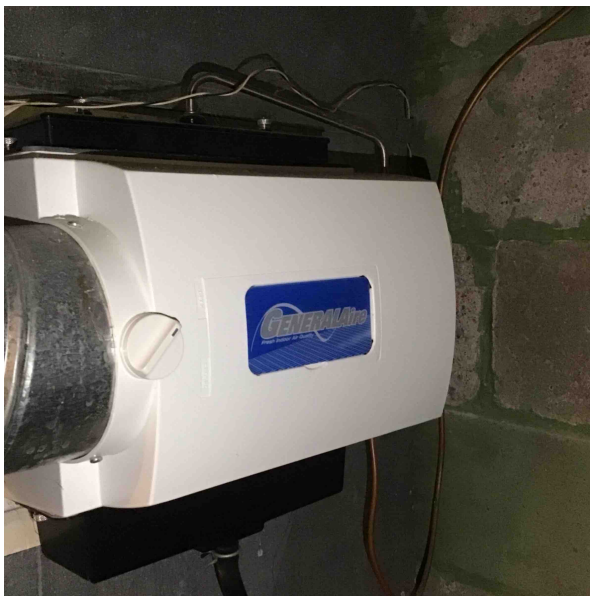
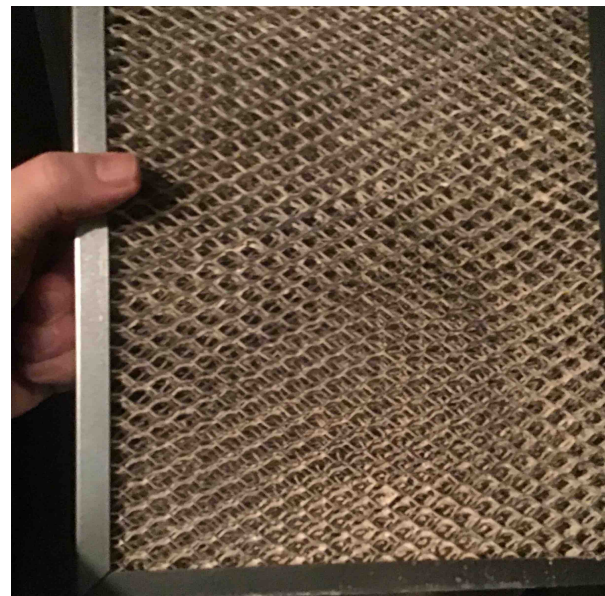
8.12.2 We would suggest cleaning and descaling the humidifier yearly at the start of the heating season. Replace evaporator pad / trickle assembly required. **(Mechanical Room / Utility Room)**

8.12.1 A humidifier is present, however the functionality was not determined. Have the unit assessed by an HVAC technician during annual servicing.

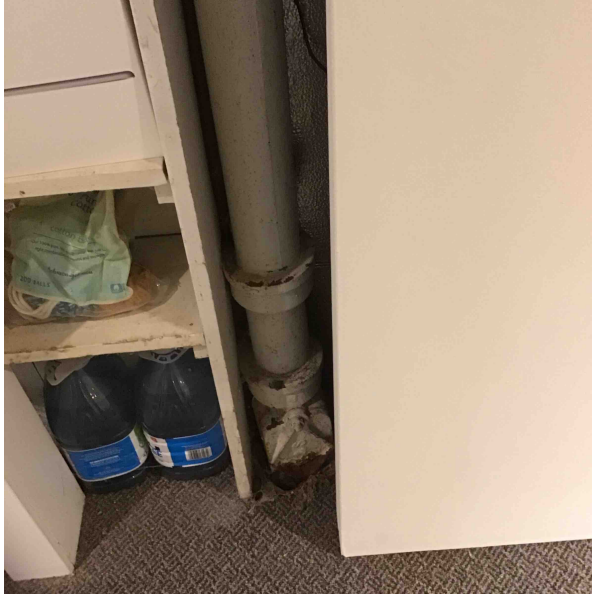
9.5.2 The drain, waste and vent piping is cast iron. A qualified plumber should further assess and upgrade / replace as required to prevent water damage due to cracking / corroding / pipe failure. **(Landing - Basement)**

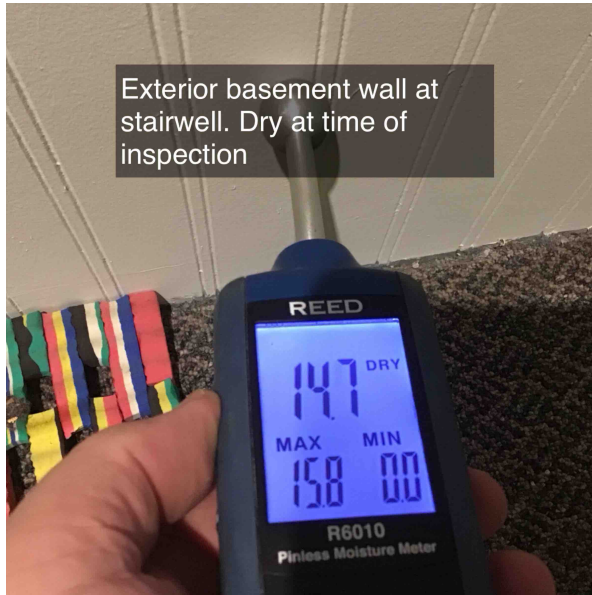
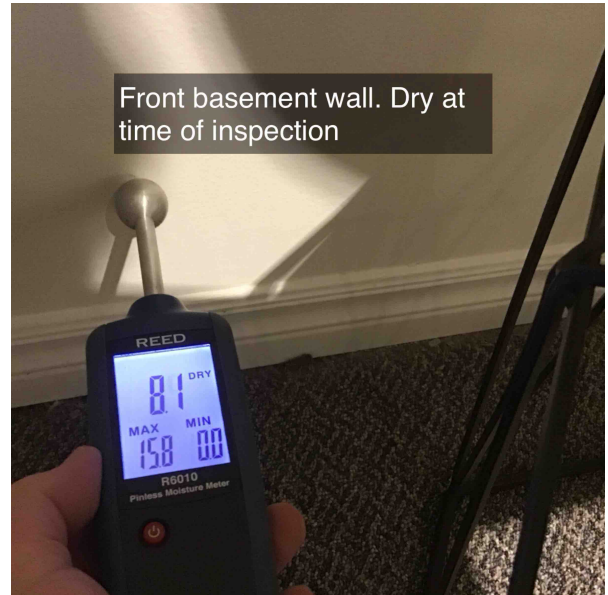
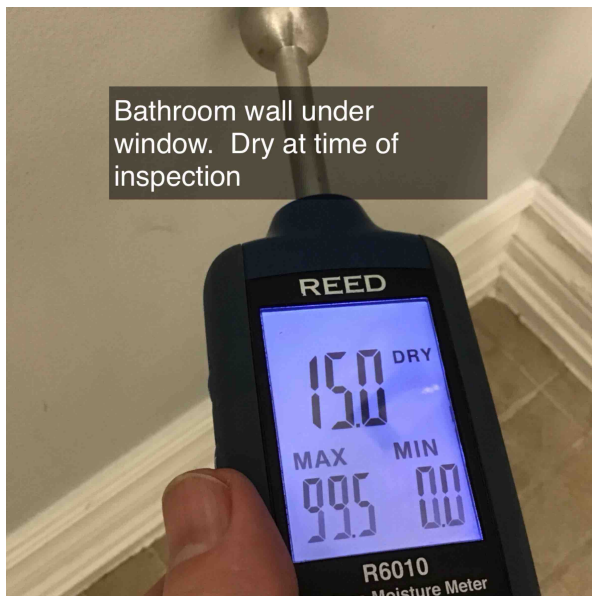
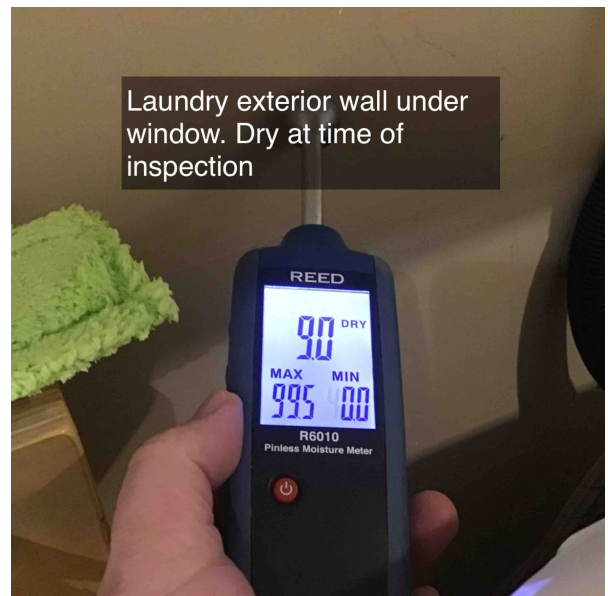
- Electrical Closet / Offset
- Landing - Basement
- Laundry / Kitchenette
- Recreation Room

10.1.2 Water penetration: Active water seepage was not detected in the accessible areas of the basement. Most water problems are the result of non-functioning eavestroughs, downspouts, or poor surface drainage. We suggest that water not be allowed to pond beside the foundation.

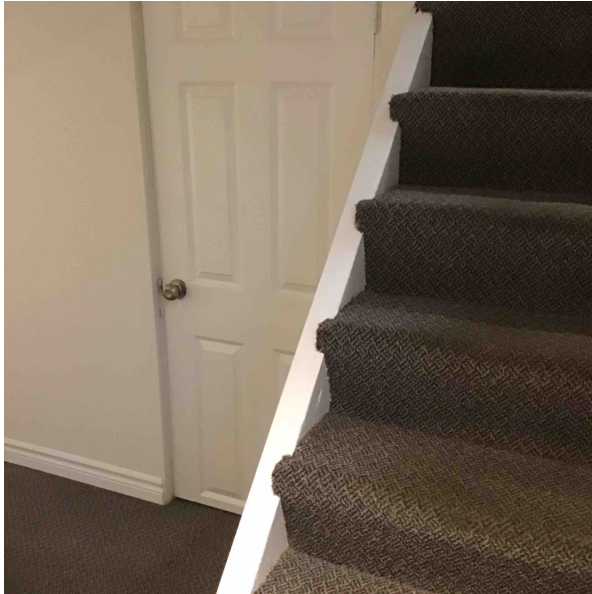
10.5.2 The guardrail is missing. Install a guardrail for health and safety. **(Landing - Basement )**

10.5.1 Advise installing a handrail for basement stairs
